# ANÁLISE DAS MANIFESTAÇÕES PATOLÓGICAS NA IGREJA DE NOSSA SENHORA DA PIEDADE DO PARAÓPEBA USANDO TERMOGRAFIA

*ANALYSIS OF PATHOLOGICAL MANIFESTATIONS IN THE MOTHER CHURCH OF NOSSA SENHORA DA PIEDADE DO PARAÓPEBA USING THERMOGRAPHY*

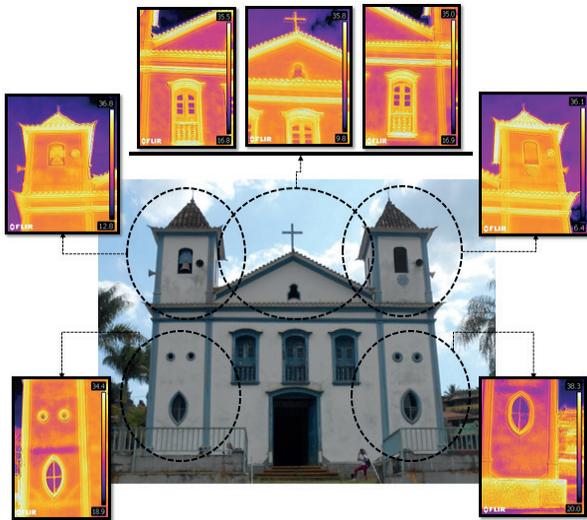
In historical buildings the main area of visual impact is the main façade. In the Church under study, the facade is preserved structurally, but it shows worn paint with bubbles, indicating infiltrations and lack of maintenance. The thermographic images, presented in Figure 4, presented several internal structural elements perceptible by the temperature difference and some points of infiltration.

**Figure 04** – Frontal facade of Mother Church of Nossa Senhora da Piedade do Paraopeba  
**Source:** Authors' collection.

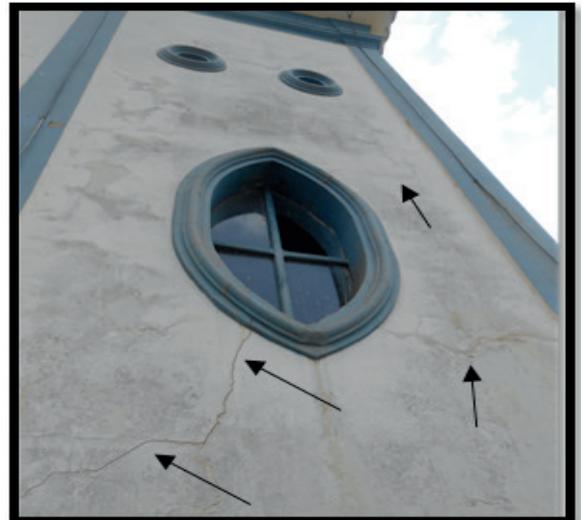
Visually it was possible to observe the appearance of cracks in the edges of the lower oval windows, as indicated in Figure 5. The windows are points of concentration of tension, because as an old building, it probably did not have constructive elements that absorb such tensions and crack propagation.

**Figure 05** – Fissures identified visually on the facade  
**Source:** Authors' collection.

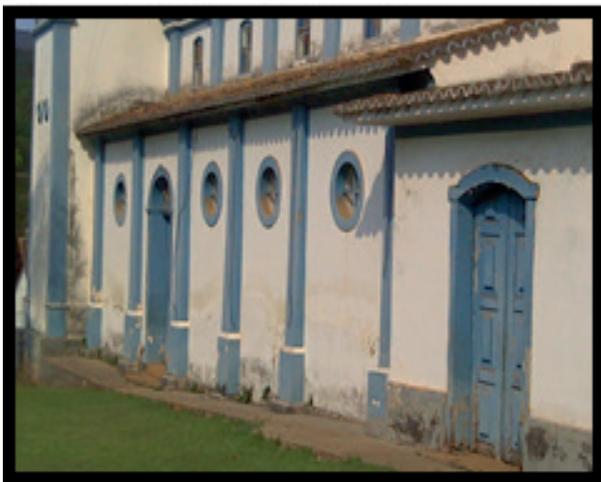
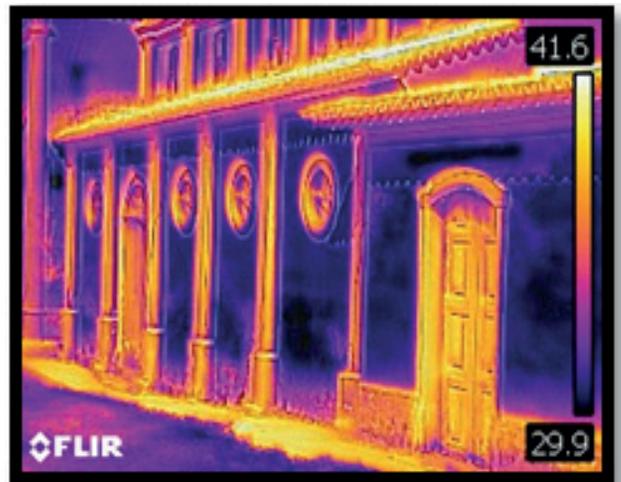
On the sides of the historic building, it was notable the higher incidence of rising humidity perhaps due to the lack of waterproofing and the deterioration caused by it, causing aesthetic damages. There were several spots in the paint and the appearance of shells and bubbles indicated

the action of water on the building. It is possible to visualize the effects of humidity on the right side of the building (see Figures 6 and 7) and on the left side (Figures 8 and 9). In Figures 7 and 8 it was identified the presence of bond beans. These doors were different from the others because they were constructed on the 60s, after the rest of the building.

**Figure 06** – Right side of the Mother Church of Nossa Senhora da Piedade do Paraopeba  
**Source:** Authors' collection.

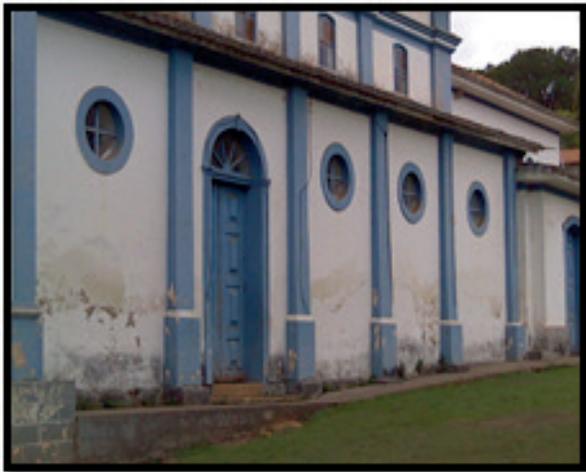
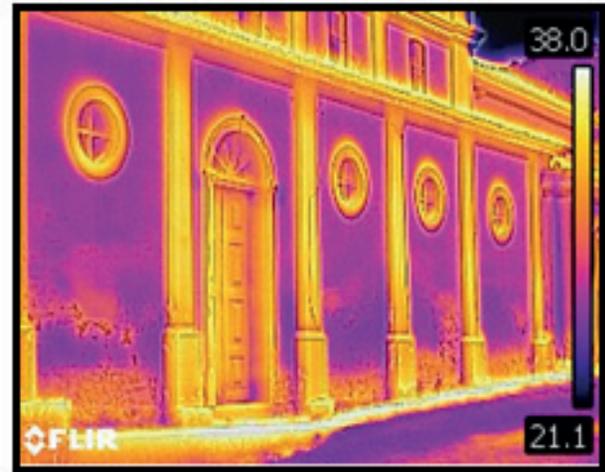
**Figure 07** – Right side of the Mother Church of Nossa Senhora da Piedade do Paraopeba  
**Source:** Authors' collection.

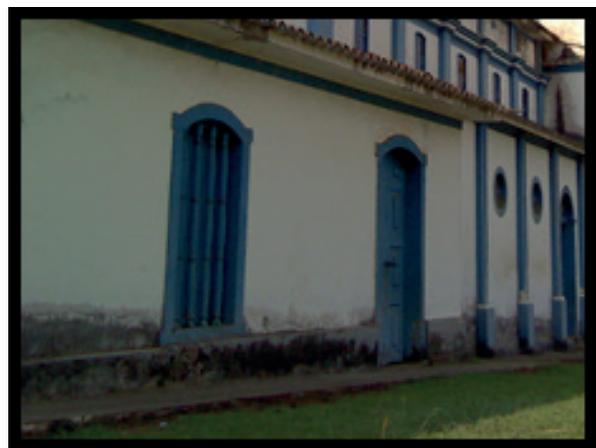
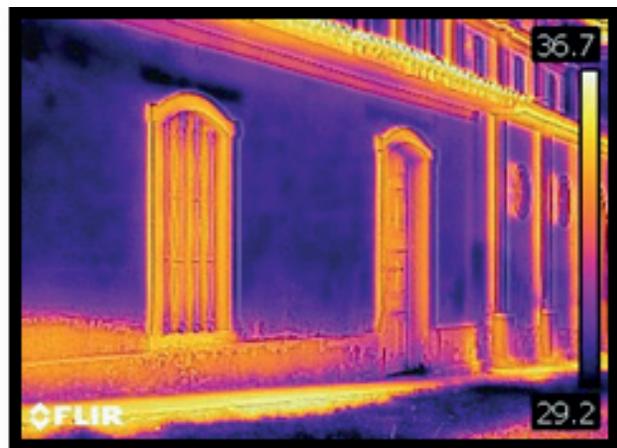
**Figure 08** – Left side of the Mother Church of Nossa Senhora da Piedade do Paraopeba  
**Source:** Authors' collection.

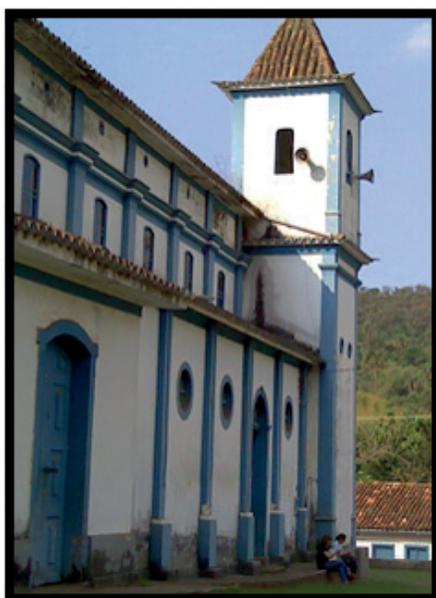
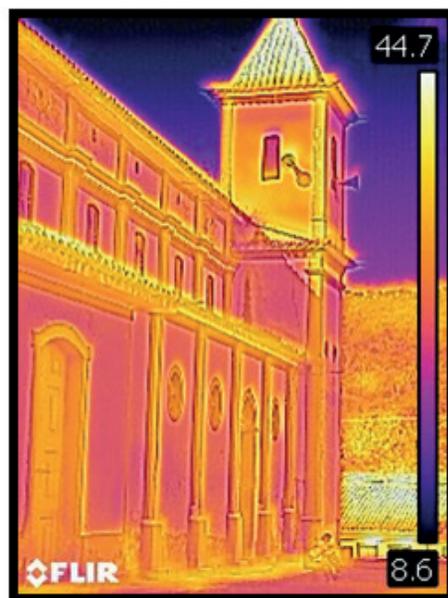
**Figure 09** – Left side of the Mother Church of Nossa Senhora da Piedade do Paraopeba  
**Source:** Authors' collection.

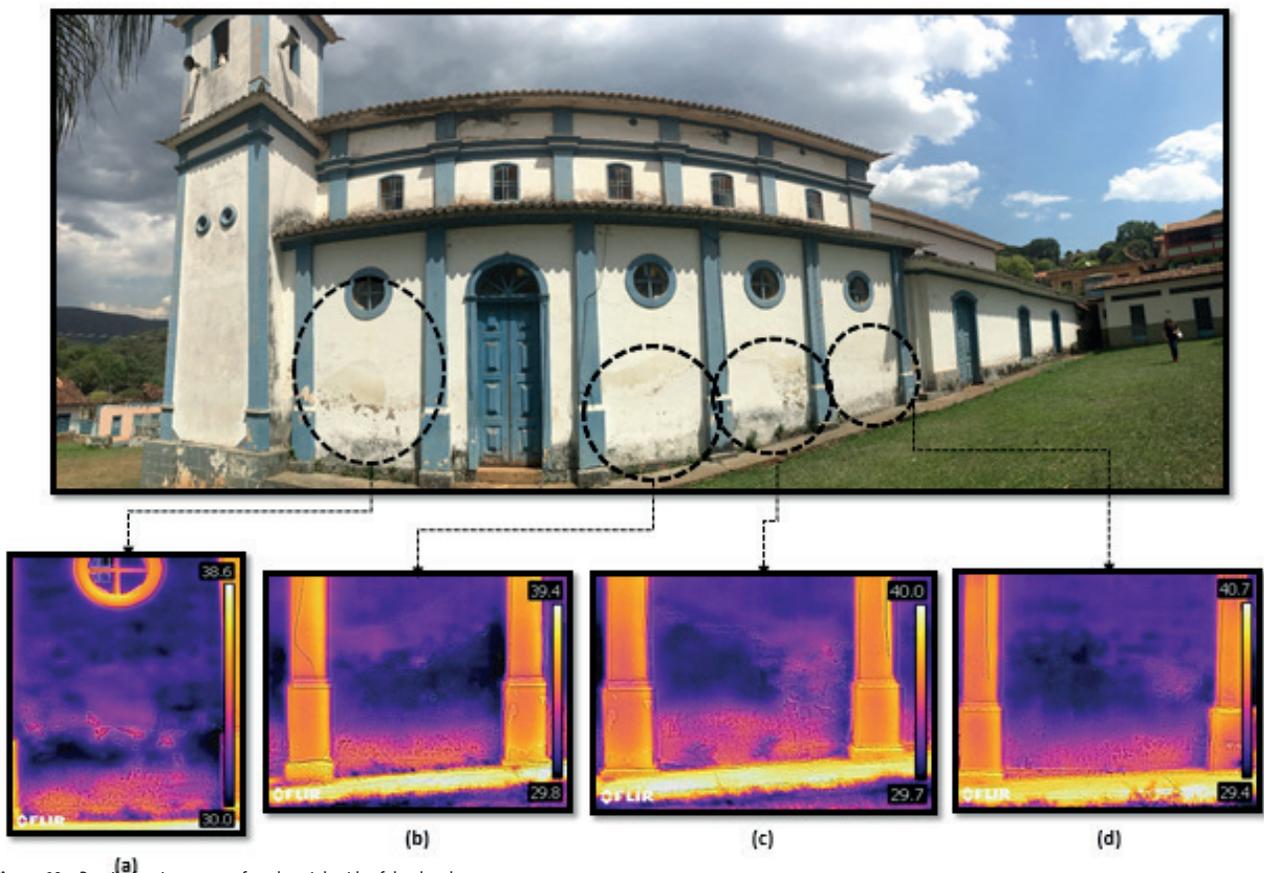
With the thermographic analysis it was possible to identify areas of concentration of internal moisture, as indicated in Figures 10 and 11. Souza (2008) affirms that the damages that are concentrated in the lower part of the walls are caused mainly because of humidity due to the proximity of the soil. The water present tends to infiltrate and to be absorbed capillary by the constituent materials up to a certain height.

It has been observed that moisture concentrates above degraded areas, this occurred maybe because the liquid evaporates more easily from the damaged surface, due to direct exposure to external heat. In addition, the walls were composed by permeable material, so the water diffuses by capillarity over an area larger than that visually apparent.

Figure 10 – Detail of moisture areas found on right side of the church  
Source: Authors' collection.

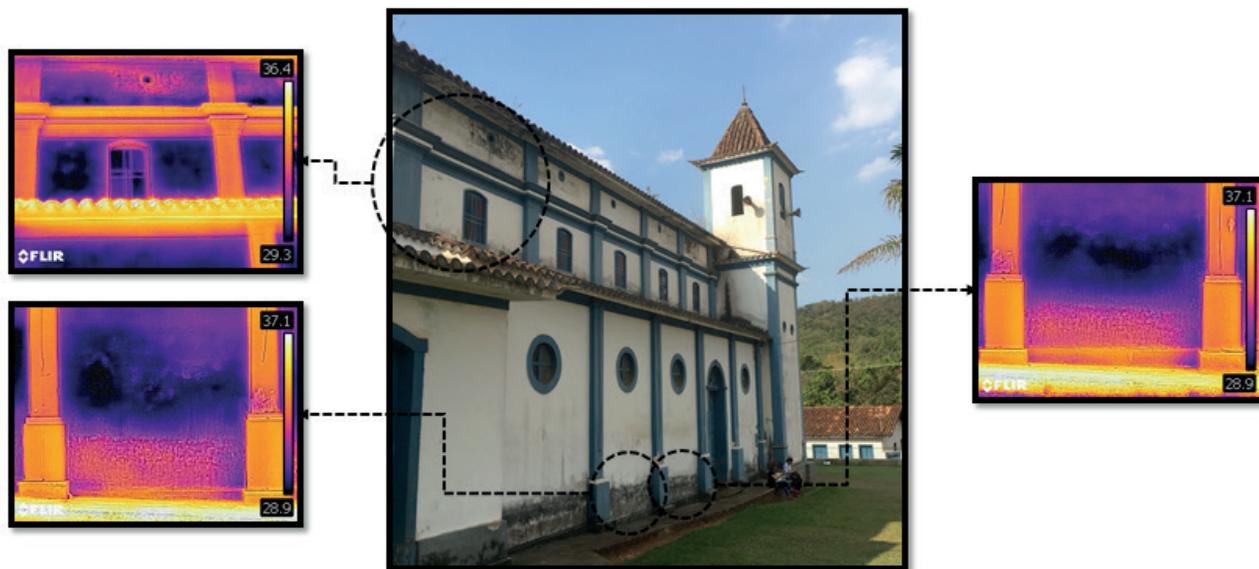
**Figure 11** – Areas of moisture concentration on the left side of the church.  
**Source:** Authors' collection.

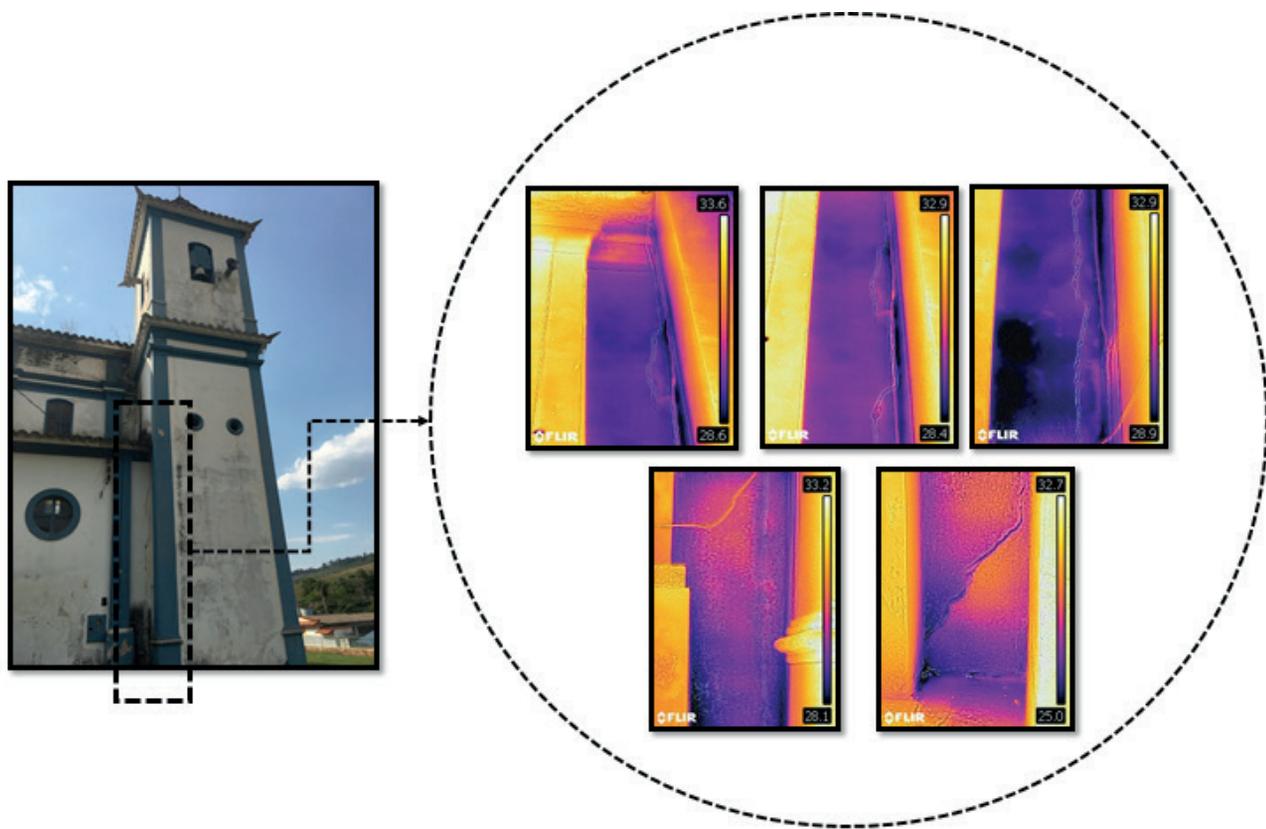
The towers of the building, since 2002, have serious structural problems, presenting considerable cracks,

even with palliative actions of installing wooden beams in the baptistery to support the chorus and relieve the load of the external walls and towers - solution that remains (Andrade, 2014). The points representing cooler areas in Figure 12 may indicate the propagation of air and water in the structural element, since the tower has cracks that allow the entry of these natural components.

**Figure 12** – Left tower of the Mother Church of Nossa Senhora da Piedade do Paraopeba  
**Source:** Authors' collection.

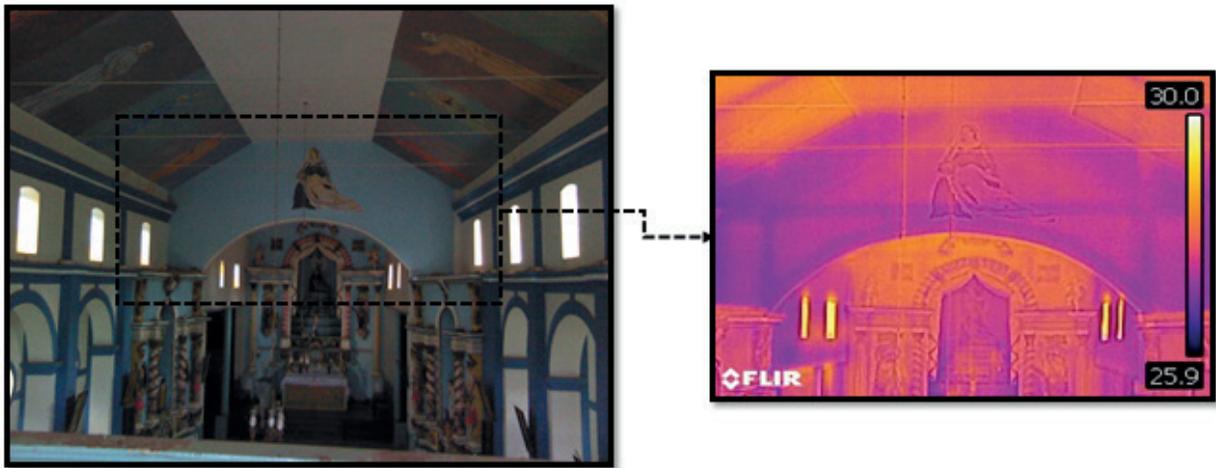
**Figure 13** – Main internal arch of the Mother Church of Nossa Senhora da Piedade do Paraopeba  
**Source:** Authors' collection.

It was verified that the interior of the building has a smaller number of pathological manifestations. The structural part of the main arch and the slabs are preserved, as can be seen in Figures 13 and 14, so that they offer no significant risk or compromise to the aesthetics of the building.

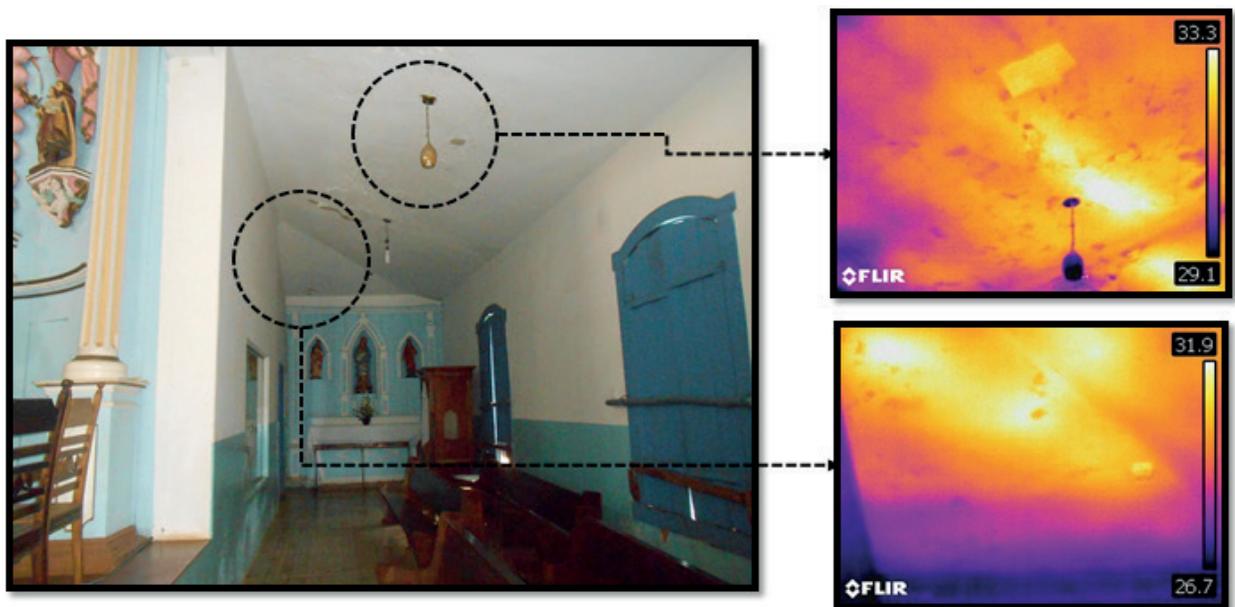
**Figure 15** – Right internal corridor of the Mother Church of Nossa Senhora da Piedade do Paraopeba  
**Source:** Authors' collection.

The slabs of the lateral corridors, presented in Figures 15 and 16, present painting problems, characterized by displacements and vesicles. Thermography indicated some regions of high temperature, which converge in a larger area, that by visual inspection had no wear near the lower surface. It is expected that such behavior occurs due to the lack of tiles or poor positioning of the tiles, allowing the entrance of sunlight and a higher incidence of heat or by the detachment of the substrate.
