# DURABILITY EVALUATION OF WATTLE AND DAUB WALL PANELS: EXPERIMENTAL HOUSING BUILDINGS 001 AND 002 IN SÃO CARLOS - SP

**HECTOR YUDI YOKOYAMA INAFUKU** | USP – Universidade de São Paulo, Brasil

**AKEMI INO, PhD** | USP – Universidade de São Paulo, Brasil

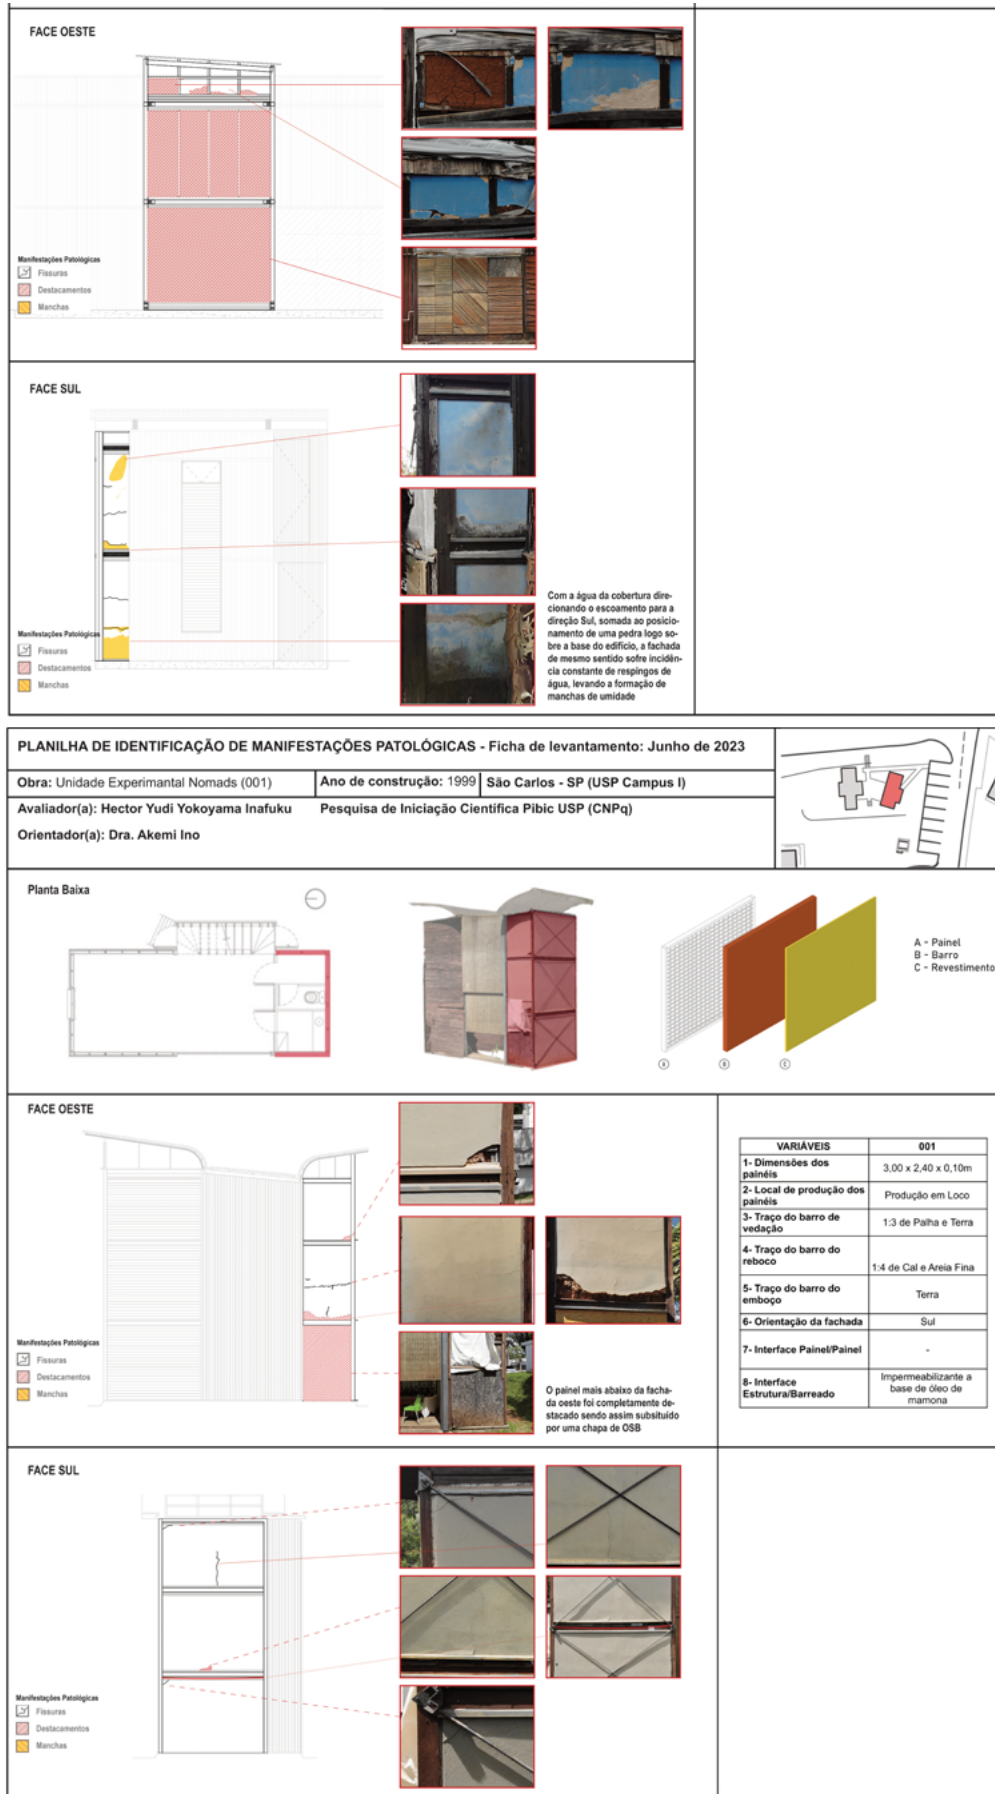
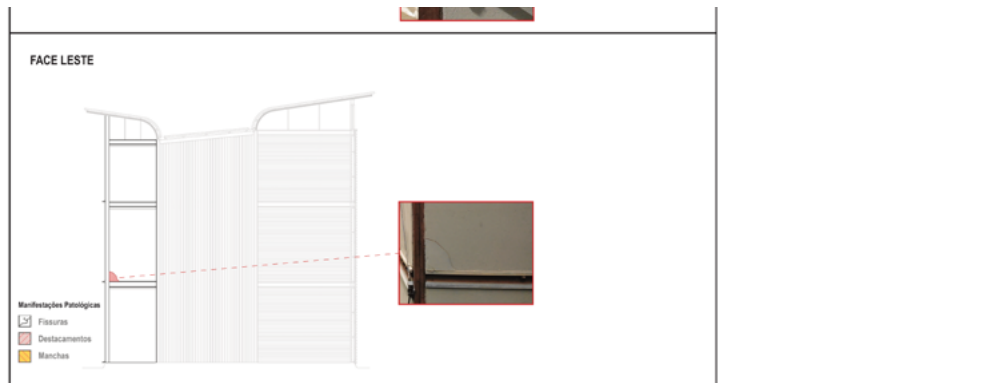
**Figure 12:** Identification Sheets for Pathological Manifestations.

Of the nine panels evaluated in Unit 001, four met all the established requirements and criteria, with two located on the South face and two on the East face. The three panels on the West face did not meet the requirements.

In Unit 002, out of the 18 panels evaluated, only four met the defined requirements and criteria, with three on the South face and one on the North face. The panels on the West face were completely removed, and the lower floor wall was replaced with OSB paneling over the sawn timber frame.

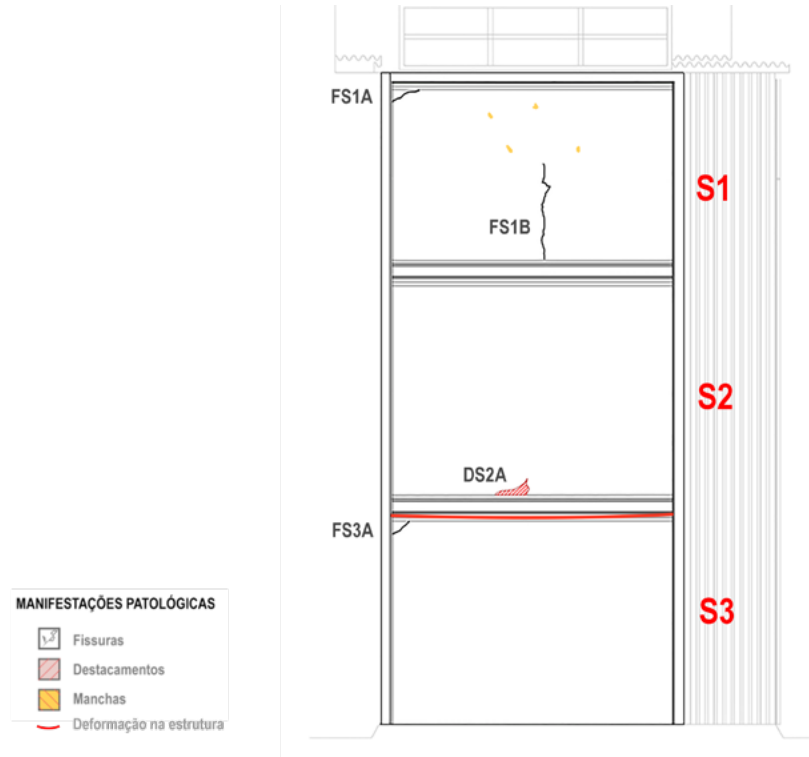
**Figure 13:** Pathological Manifestations on the South Façade (Unit 001).

structure caused by under dimensioning, which, due to wind, may have contributed to the formation of cracks at the corners. Both FS1B and DS2A could be related to deformation in the lower beam, which is more noticeable in panel S2, as indicated by the horizontal line in Figure 13. This deformation may have led to the weight of the earth contributing to the formation of these cracks.

In the panels facing the South side (S1; S2; S3) of Unit 001, shown in Figure 13, a total of four stains and two cracks were identified in panel S1, with one located at the upper left corner (FS1A) and another running vertically from the base towards the top of the panel (FS1B). In panels S2 and S3, a detachment (DS2A) was identified, similar to FS1B, also at the base of the panel on the beam structure, along with a crack (FS3A) found at the upper left corner of panel S3.

Among the possible causes for the formation of cracks FS1A and FS3A is potential movement in the

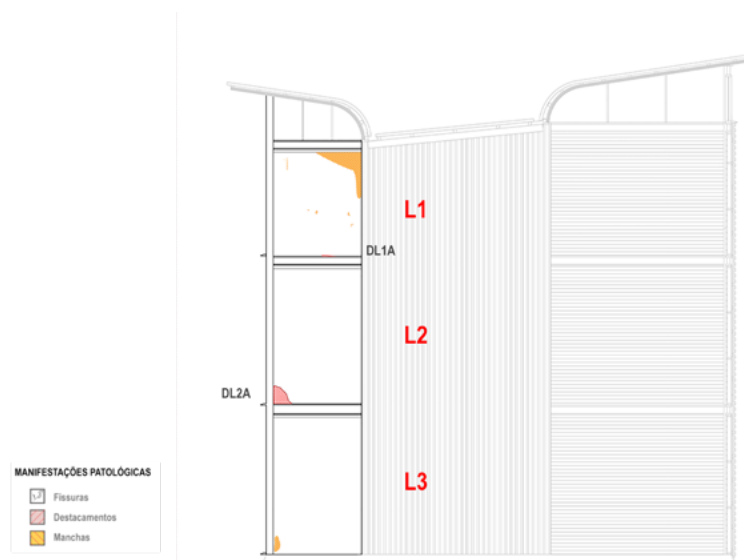
**Figure 14:** Pathological Manifestations on the East Façade (Unit 001).

Regarding the East face (L1; L2; L3), shown in Figure 14, the identified issues are mostly stains, with only one detachment (DL2A) located at the lower left corner of panel L2.

Both the East and West faces show good performance in terms of the interfaces between the earth and the wooden structure, which may be attributed to the castor oil resin applied in the mixed technique.

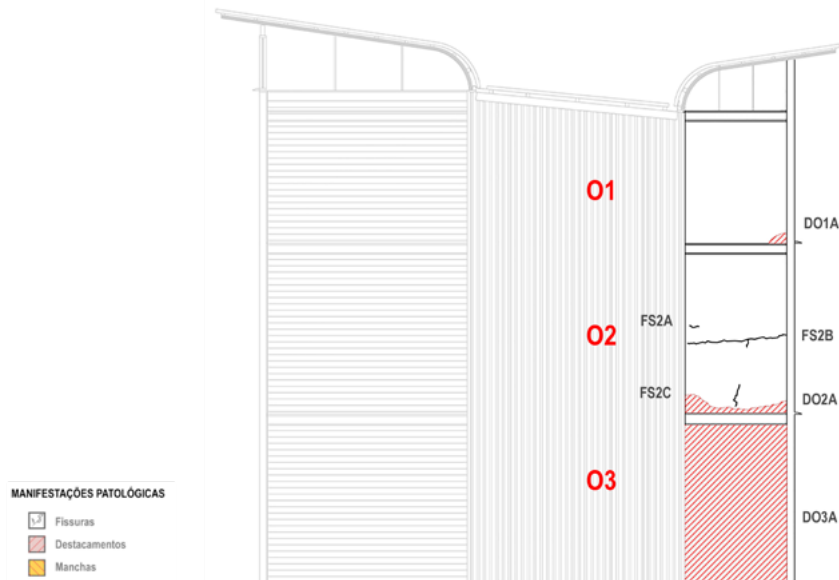
**Figure 15:** Pathological Manifestations on the South Façade (Unit 001).

The West face stands out compared to the others due to the severity of its issues. In addition to the crack (FO1A), both panels O1 and O2 show significant detachments (DO1A; DO2B) concentrated in the lower region of the panel, as well as a detachment (DO2A) in panel O2 at the earth-structure interface. Panel O3 is notable for the complete removal of the earth and its coating (Figure 15).

When analyzing the three façades, a pattern of concentrated cracks and detachments at the corners of the panels (FS1A; FS3A; DL2A; DO1A; DO2A) becomes evident. A possible cause of this pattern is the movement of the structure due to wind, making the corner regions susceptible to cracking. Consequently, the presence of cracks and deformations facilitates water infiltration into the seal, leading to the rotting of the framework and detachment of the earth.

The temperature fluctuations experienced by the panels on the West face in the late afternoon may also be a possible reason for none of the panels meeting the established requirements. Combined with the previously mentioned issues, the identified pathologies manifestations could be related to the dimensional variation of the wood caused by temperature changes, affecting the material interfaces and contributing to water infiltration and accumulation in the wooden framework, leading to its decay.

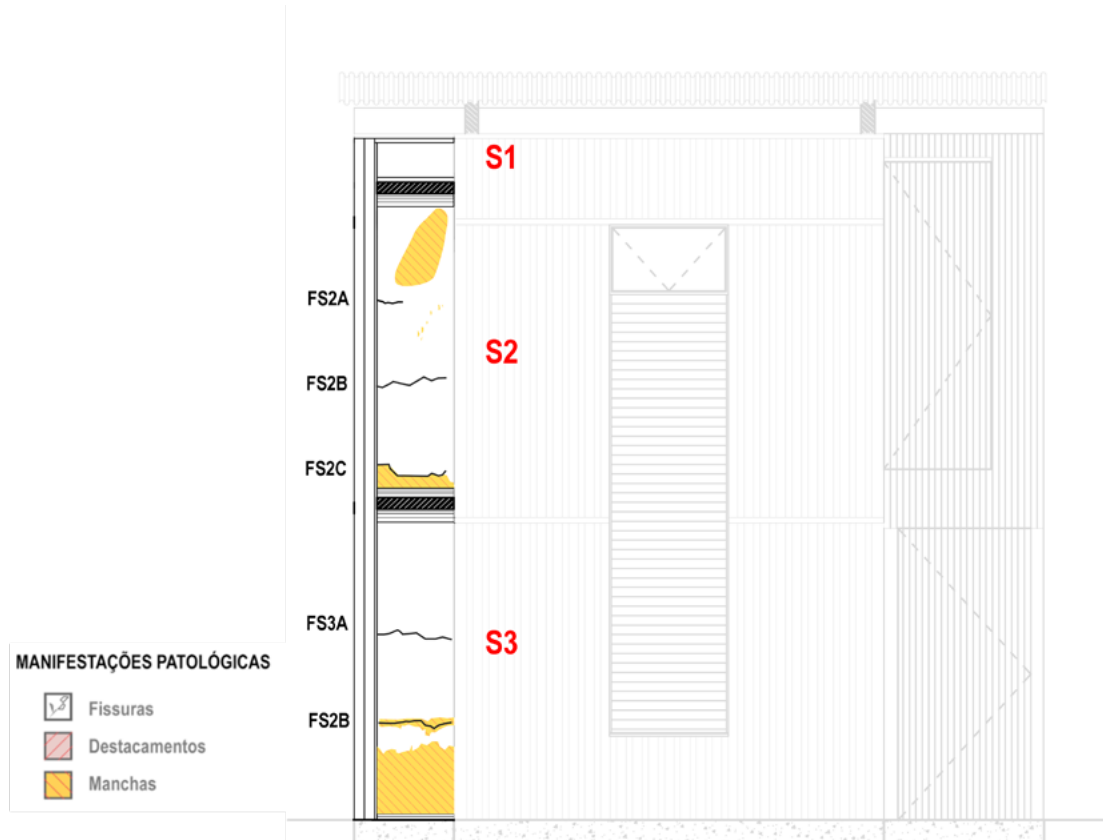
**Figure 16:** Pathological Manifestations on the South Façade (Unit 001).

On the South face (Figure 16), there is a predominance of moisture stains caused by direct contact with water splashes. Despite this, it is the only face without any detachments, having only cracks with less than 1 mm of width.

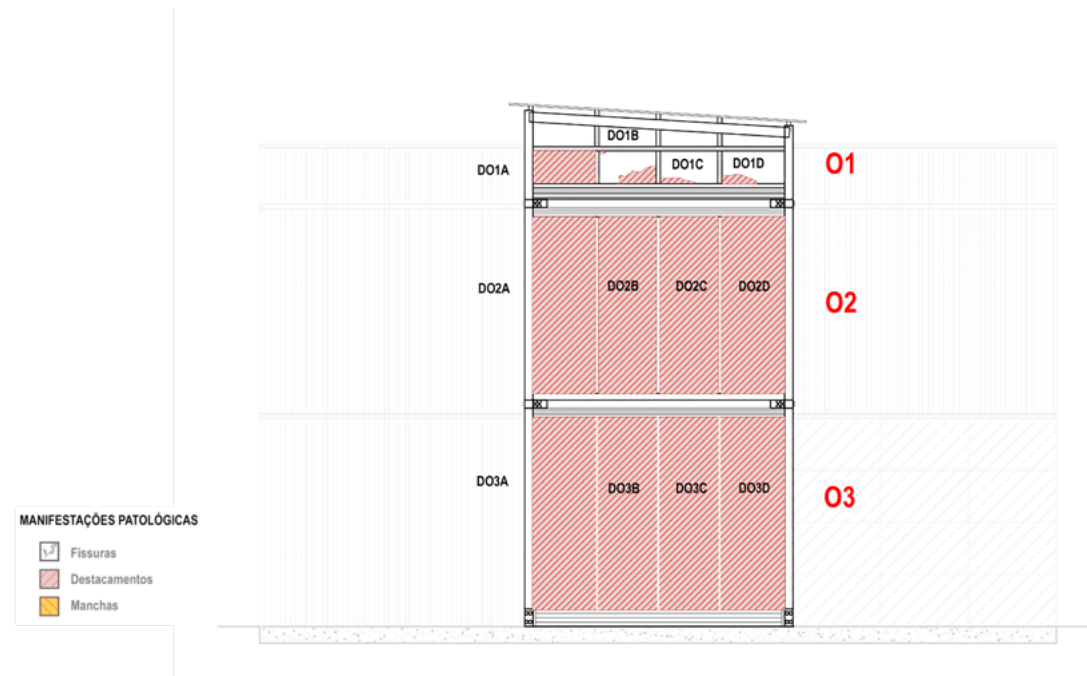
**Figure 17:** Pathological Manifestations on the South Façade (Unit 001)

The West face (Figure 17) has the highest number of sealant detachments, with faces O2 and O3 being completely detached.

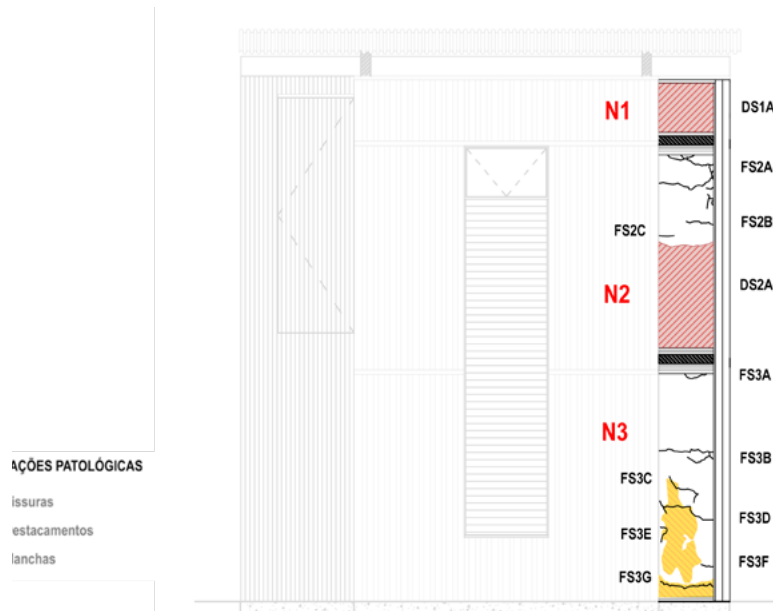
**Figure 18:** Pathological Manifestations on the South Façade (Unit 001).  
**Source:** Elaborated by the Authors (2022)

The North face (Figure 18) shows complete detachment in panel N1 and partial detachment in panel N2, with a significant presence of cracks. Additionally, there is extensive moisture staining on panel N3, particularly near the ground.
