USE OF ACOUSTIC TOMOGRAPH FOR DETECTING INTERNAL FAULTS IN WOODEN PARTS

MATHEUS BARRETO DE GÓES, Msc. | UFMG - Universidade Federal de Minas Gerais, Brasil.

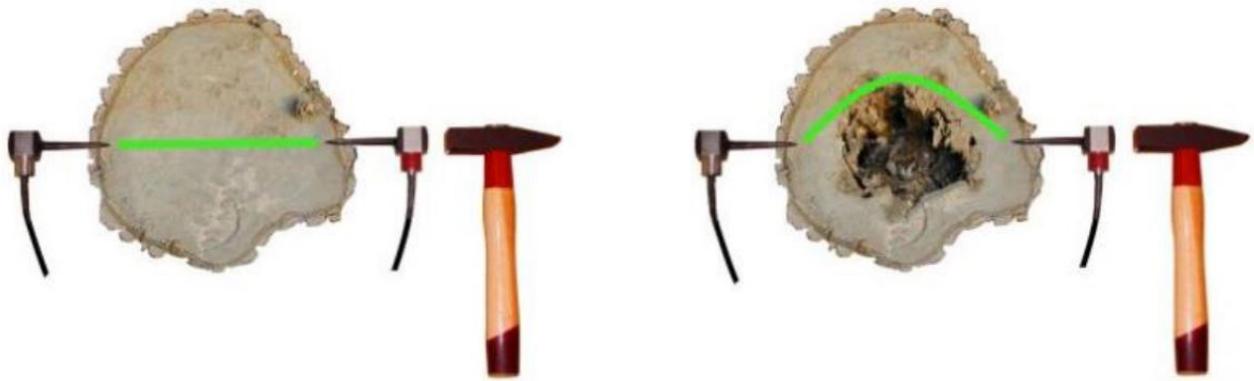
Figure 1: Path followed by the sound wave inside the wood.
Source: Fakopp (2020).

The sensors are steel nails hammered into a wooden element around its perimeter at regular intervals. Hammering a sensor creates sound waves whose speed is recorded by another sensor (Figure 1). The sensors are hammered to a depth of about 15 mm, meaning the sonic scan of a specific section of the measured element is miniaturized when compared to its actual dimension (MAKÝŠ et al., 2018).
